Manhole Inspection Summary

Manhole # S25M__018MH

Insp Date: **3/5/08 12:43 PM**

Location Address: **1110 South Carey Street**

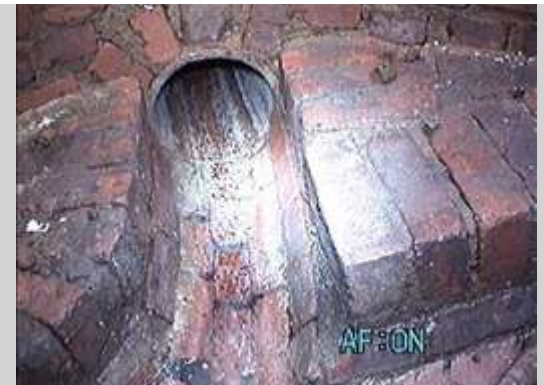
3 O'Clock Inflow

Pipe Height: **8.4** (in.) Rod and Bar (Angled)
Pipe Material: **Clay** ☐ Pipe Lined
Invert Depth: **6.93** (ft.) Flow Characteristics: **None**
Deposits: ☒ None ☐ Mud ☐ Sludge ☐ Debris ☐ Grease
Silt Depth: **0** (in.) Deposits Extent:
Infiltration: **None** Pipe Seal Cond: **Sound**

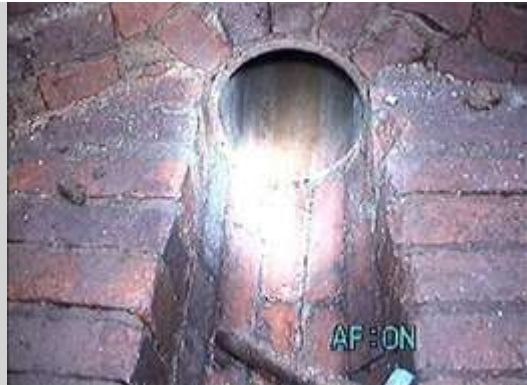
6 O'Clock Inflow

Infiltration: **None** Pipe Seal Cond: **Sound**
